TECHNICAL REPORT C-19  
June 1975

EMP SHIELDING PROPERTIES OF CONDUIT  
SYSTEMS AND RELATED HARDWARE

by  
D. J. Lovrenz  
P. H. Nielsen  
R. G. McCormack

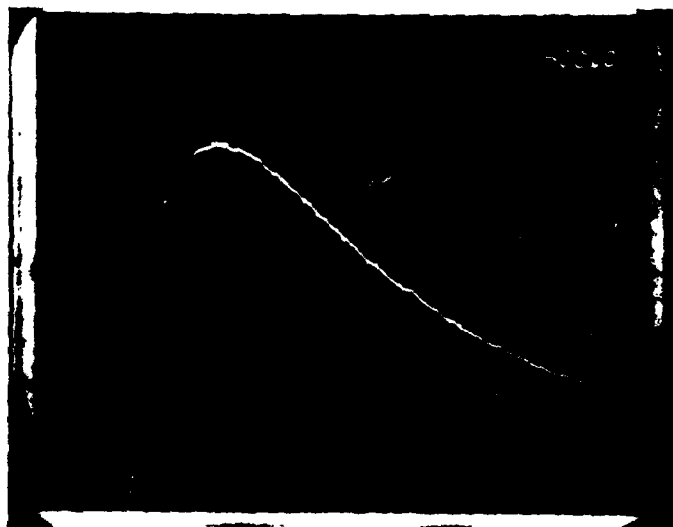
(a) Vertical: 1000 x 50 mV/div  
Horizontal: 200  $\mu$ sec/div

(b) Vertical: 1000 x 50 mV/div  
Horizontal: 500  $\mu$ sec/div

Figure 11. Diffusion signal for 1-in. galvanized steel conduit showing sense wire voltage.

Conclusions. From the results presented in the previous section, the function for  $v_I^n(t)$  and the value of  $M$  can be obtained by normalizing the data given in Figures 11 and 12. The values for  $v_I^n(t)$  can be obtained for 1-in. and 2-in. galvanized-steel conduit. These functions agree with the analytical value for  $v_I^n(t)$ . From values given in Table 1 the value for  $M$  can be found. Using Eq 1-12, the sense-wire diffusion current for any conduit-current sense-wire connection and conduit length can be found. This provides a base-line signal for the conduit system and should give a meaningful basis for use in evaluating the seriousness of the leakage signals described in the next two chapters.

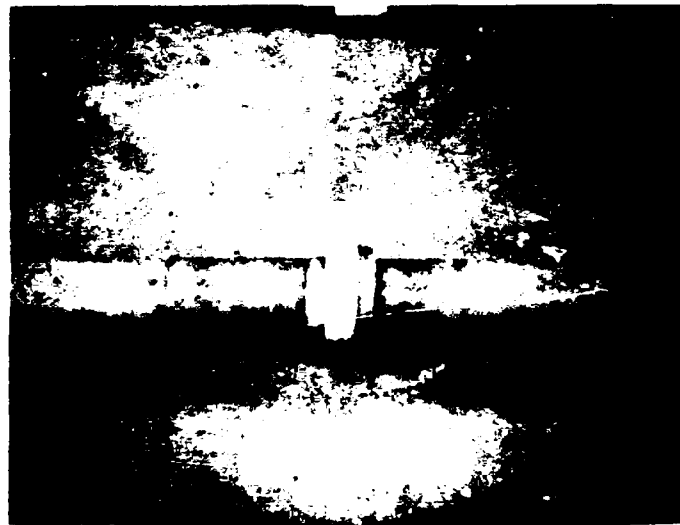
Figure 17. Test sample of 4-in. explosion-proof union installed on conduit sections.

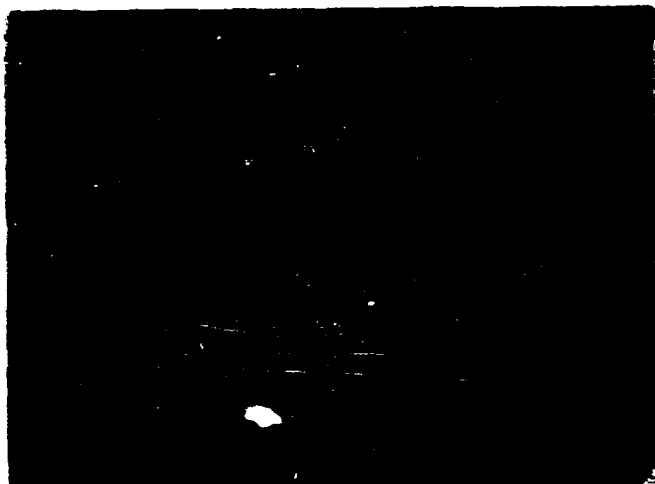
Figure 21. Non-RFI tight flexible conduit sample (Sealtite) without ground wire.

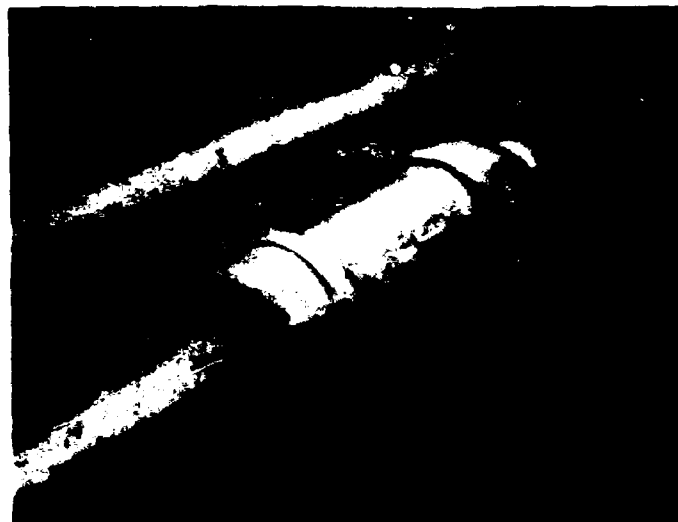
Lock nut  
(other  
lock nut  
on inside  
of end  
cap)

End cap  
with hole  
drilled to  
accept  
conduit

Figure 40. Close-up of lock-nut test assembly.

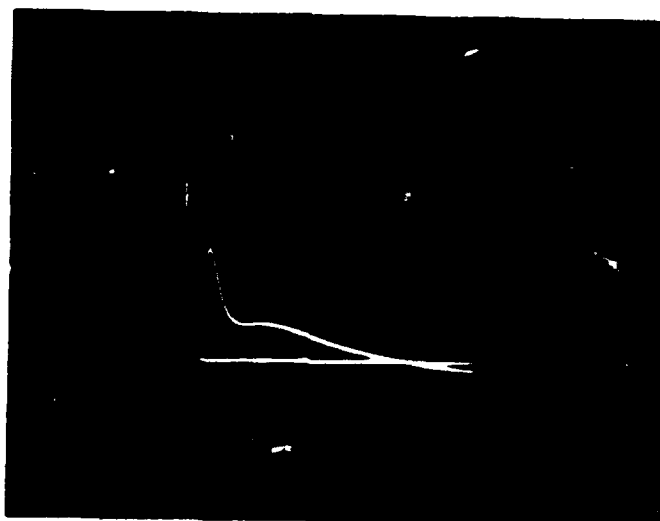
Figure 51.  $I_{sc}$  wave form--1 1/2-in. special design flexible conduit  
( $i = 10 \text{ mA/div}$ ;  $t = 0.5 \text{ msec/div}$ ).
